Non Technical Summary

Former Visteon Factory Land Contamination and Remediation

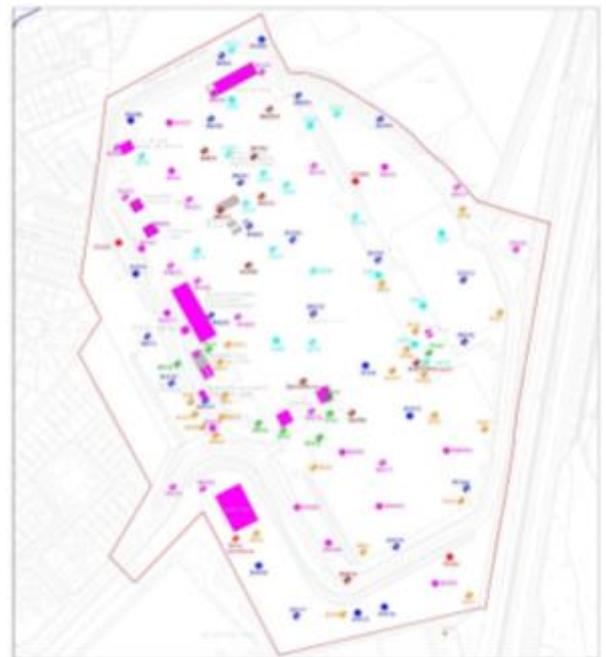
2006-2014 Investigation Locations

These previous assessments identified the following sources of contamination to be present at the site:-

In soils:

- Heavy metals, namely nickel, lead in some areas, and asbestos contamination present within shallow soils;
- Hydrocarbons (from fuels such as heating oils, diesels), TCE (Trichloroethylene – commonly used as a degreaser for metal parts).

In shallow groundwater:

- hydrocarbons (from fuels) and TCE.

In deeper groundwater in the sandstone bedrock aquifer:

- Hydrocarbons and TCE.

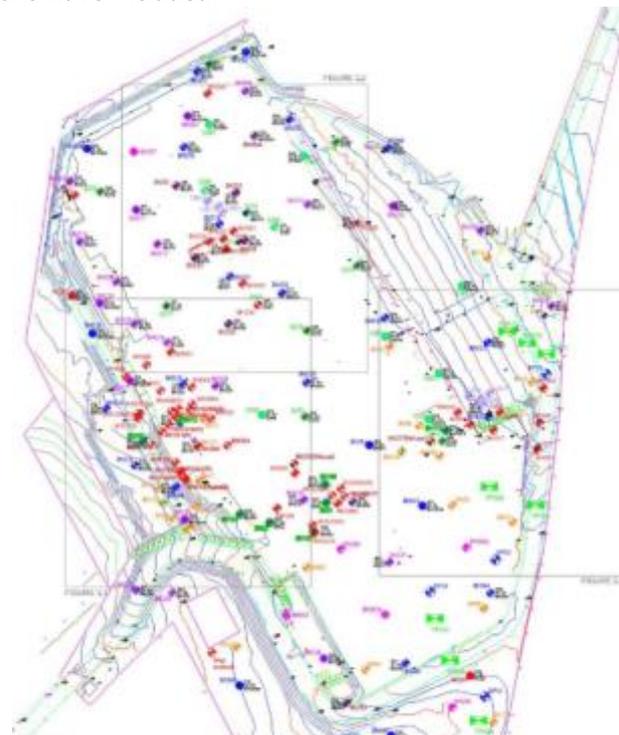
2006-2016 Investigation Locations

The site investigations and risk assessments completed to date have identified a number of areas of contamination.

The following is a short summary of the investigation findings:

- Site wide nickel (metal), TCE and asbestos contamination in made ground soils;
- Lead (metal) and hydrocarbon (fuel) soil contamination;
- Isolated free product hydrocarbon (fuel) areas in soils and in groundwater;
- Elevated ground gas – carbon dioxide and soil vapour TCE, and
- TCE in deeper groundwater in Sandstone.

The updated risk assessment concluded that soils on site only require remediation to protect the health of residents and persons visiting the site. Consequently, all gardens and landscaped areas will be provided with a capping layer and all buildings with gas protection measures which include a membrane that will stop contaminated vapours from entering the buildings from the ground below.

A capping layer is the placement of clean material (soil and stone) on top of contaminated soils. The capping layer at the Visteon site will be a minimum of 0.8m thick. A capping layer prevents contact with the underlying soil and provides a layer of clean soil for growing vegetables, grass and plants.

In summary the remedial works are:

1. Tanks were decommissioned and removed from site when the factory was demolished in 2014-2015.
2. Shallow soils are contaminated with metals, low risk asbestos, TCE (trichloroethene), isolated areas of hydrocarbons (fuels) and ground gases. for which the remediation method proposed involves by providing a capping layer to all gardens and open spaces and a membrane to houses and other. Remediation will ensure future residents on site and existing residences off site are not exposed to contamination present on the Visteon Site. The proposed remediation includes the installation of capping layers in garden and open space areas and membranes beneath houses and other buildings which will prevent persons from coming into contact with contamination;

3. Clean soils for use in the capping layer will be excavated from a Borrow Pit located in the commercial area in the southeast of the site. The void formed will be backfilled with made ground impacted with asbestos and will be provided with a capping layer that will cover the material so that it poses no risk to residents on or off site and or persons visiting the site;

4. Soils and groundwater impacted by free product hydrocarbons (fuels) will be dug out and removed from site; and
5. Remediation of TCE identified within the Sherwood Sandstone using a method called Monitored Natural Attenuation (MNA), with a contingency for enhancement at a later date should the contamination not break down naturally or quickly enough. Monitored Natural Attenuation involves careful monitoring and review of the groundwater contamination levels and movement in the Sherwood Sandstone Bedrock Aquifer over time. The aim of MNA is to
